BUREAU OF SHIPS GROUP
TECHNICAL INSPECTION REPORT

⑥ OPERATION CROSSROADS,
U.S.S. NEW YORK (BB34).

TEST BAKER

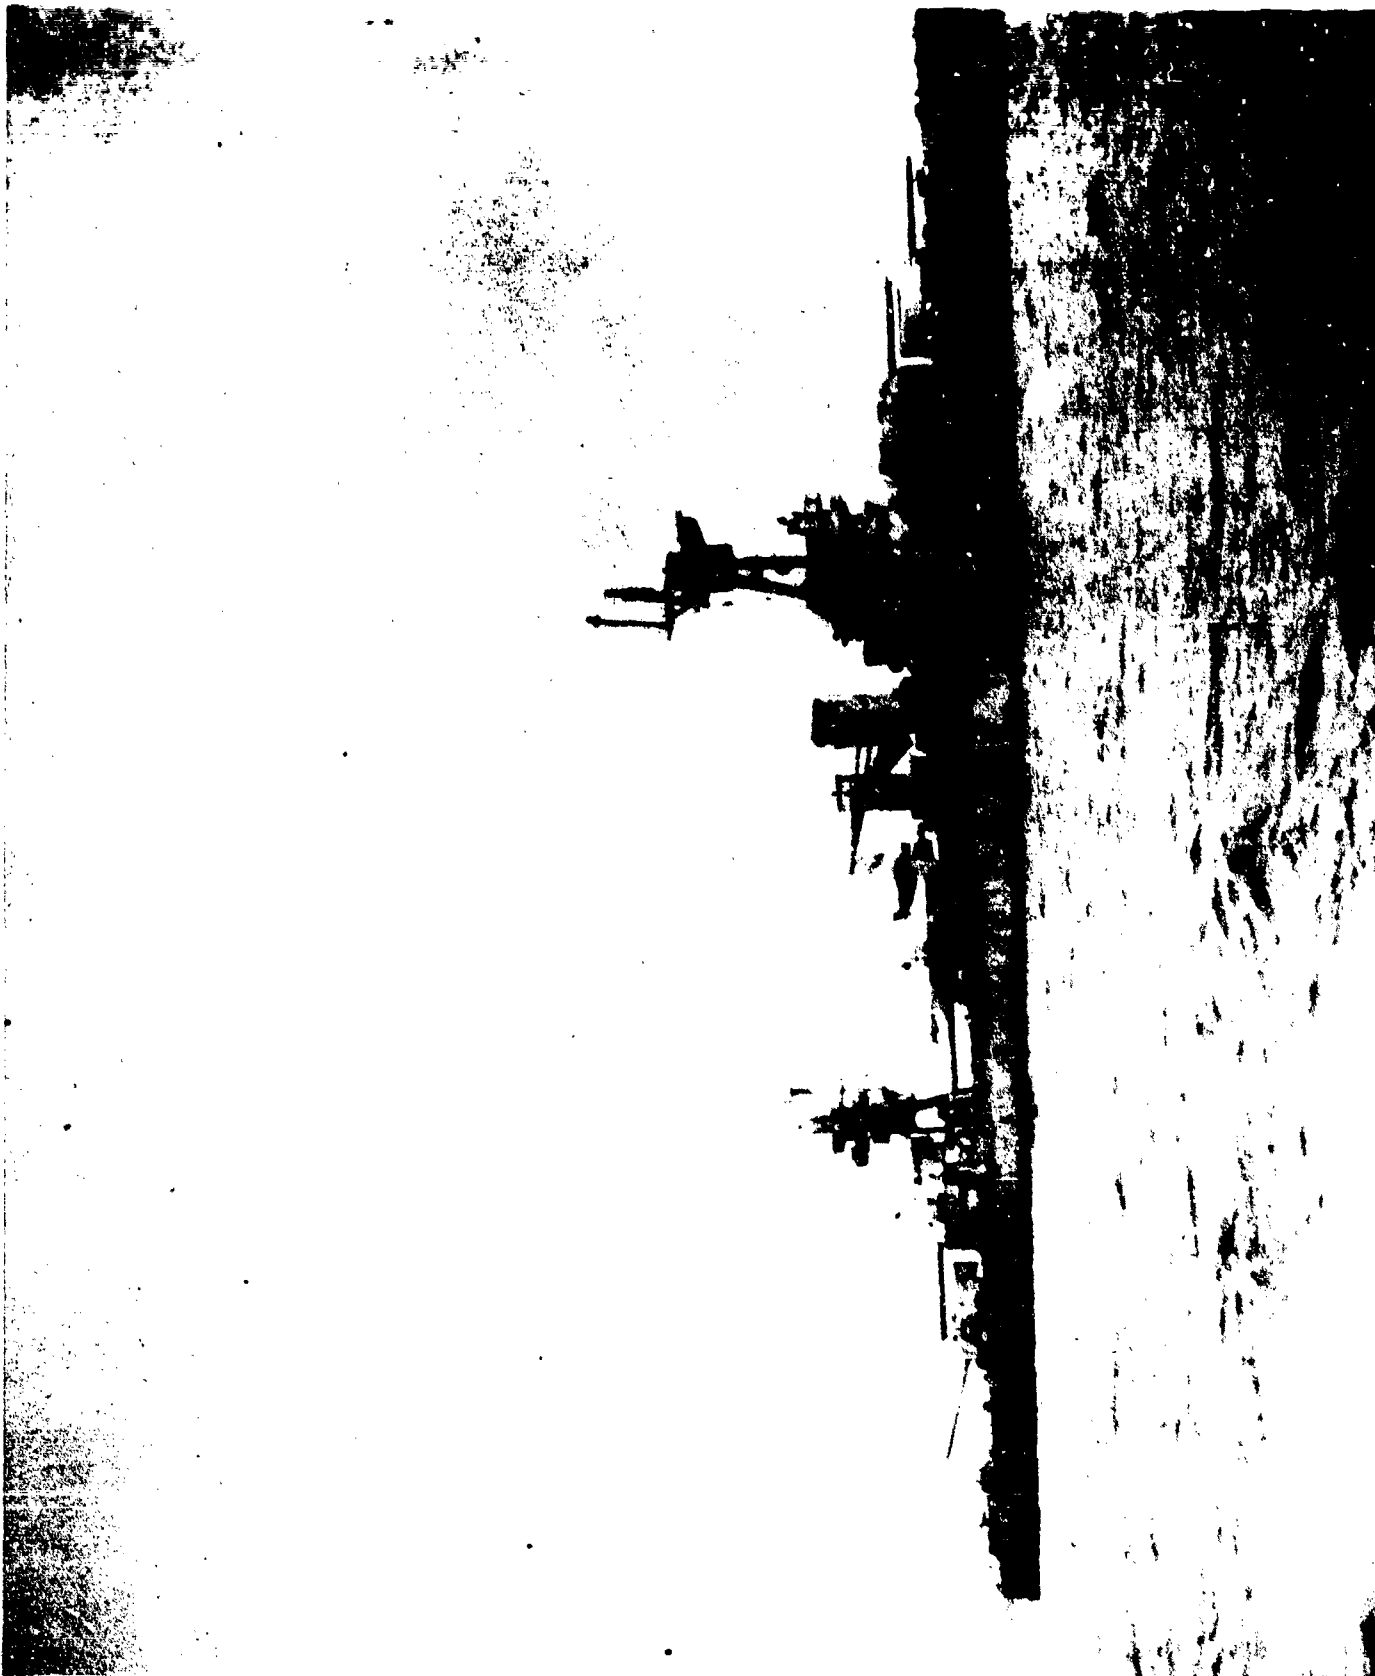
AB-CR-227-289-67. View from off starboard beam after Test B.

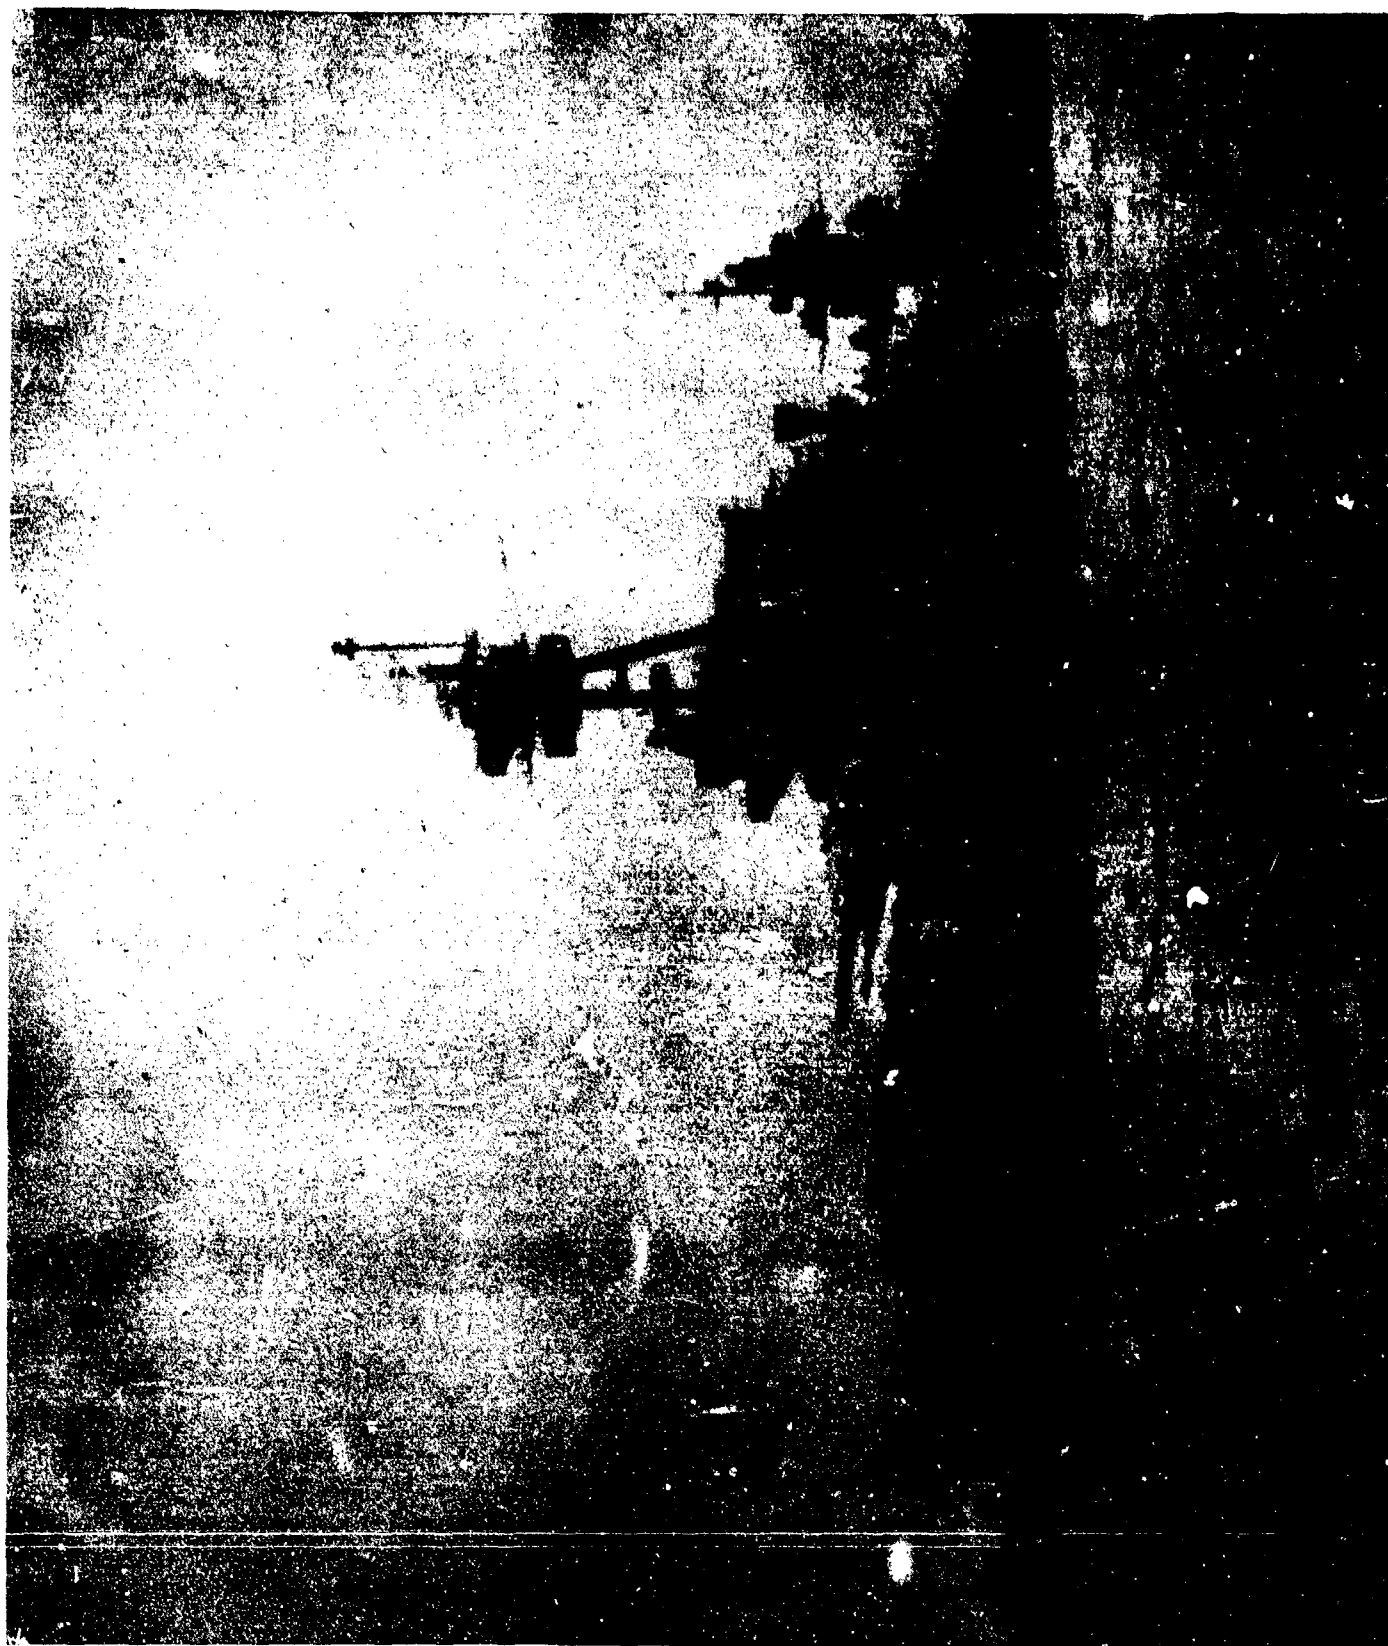
BB-CR-227-501-116. View from off port bow before Test B.

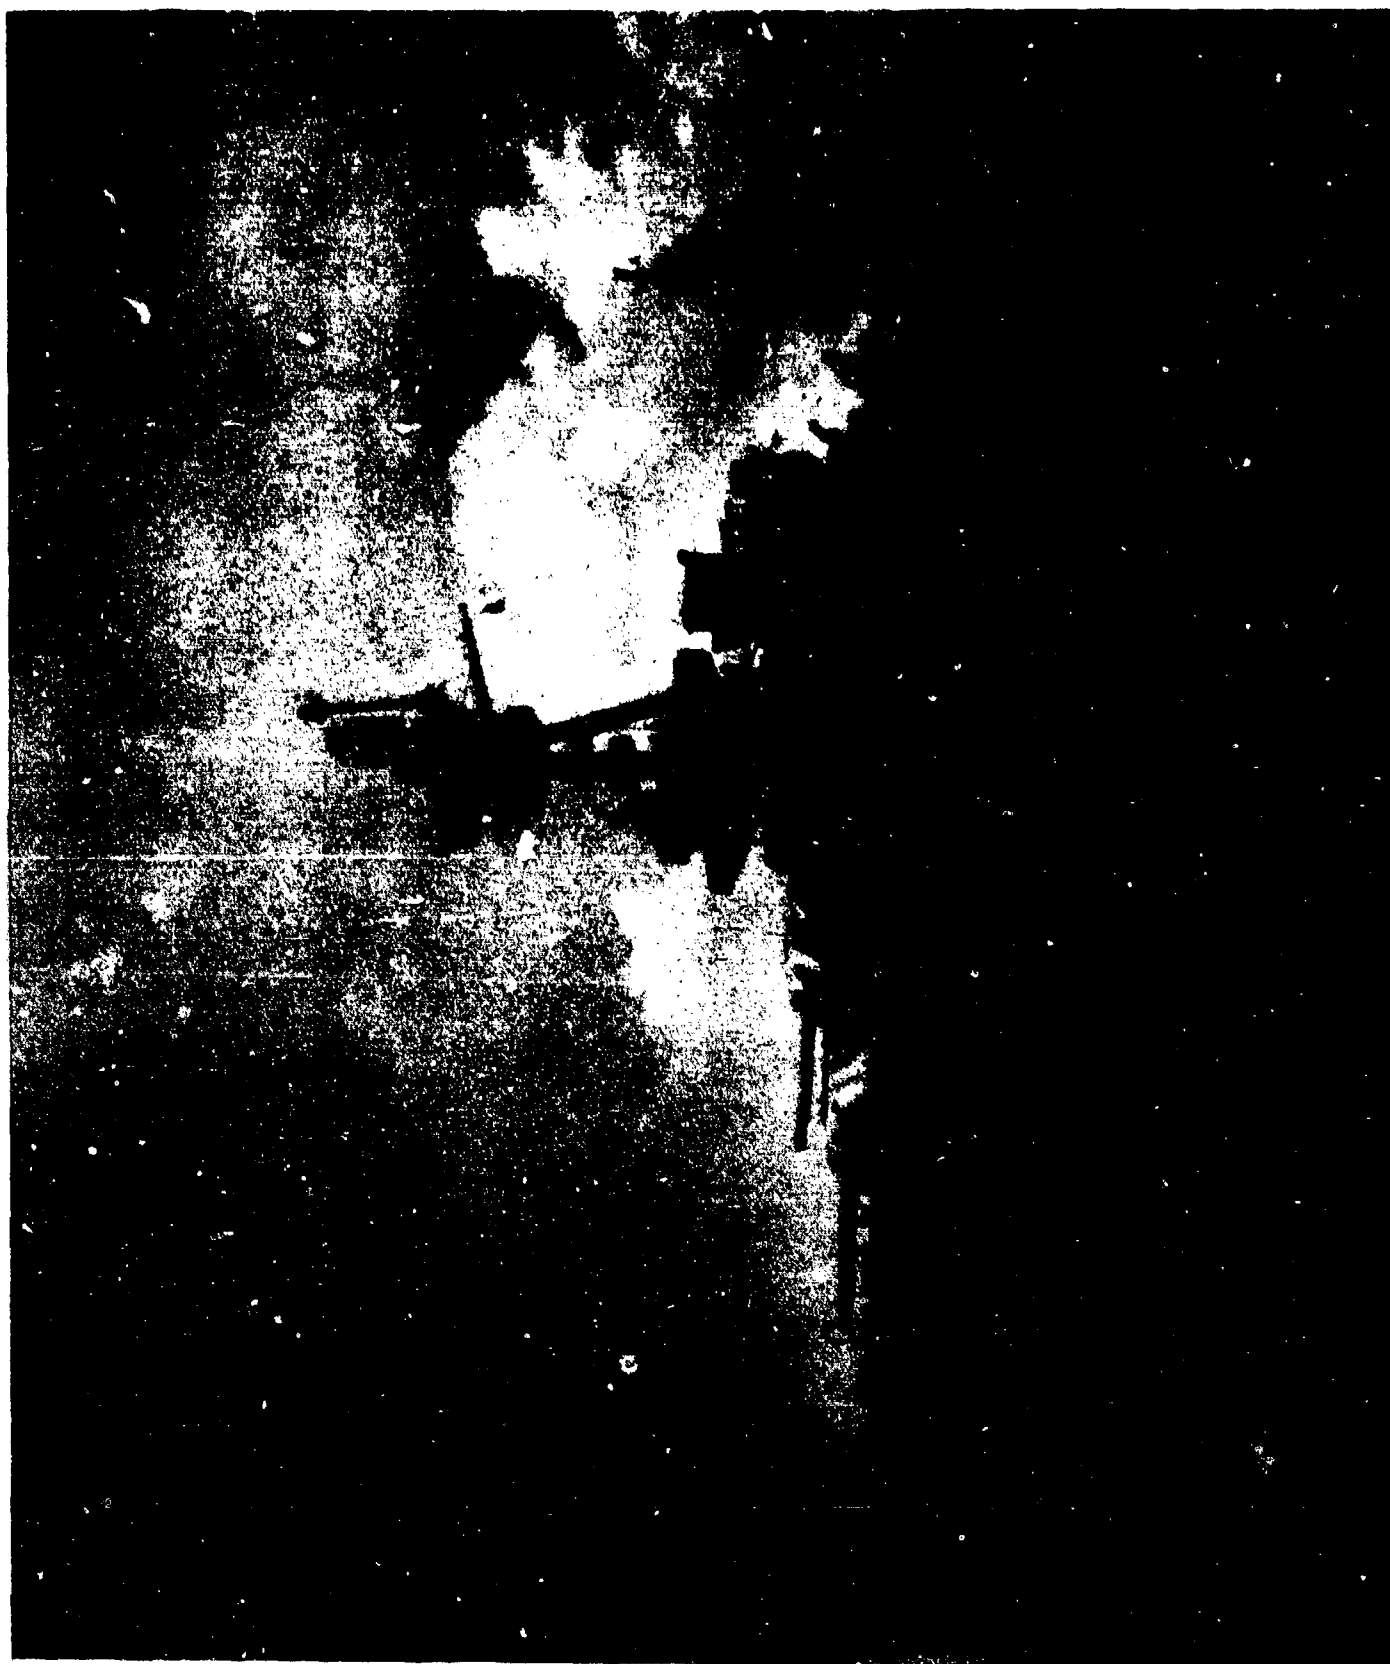
AB-CR-227-289-70. View from off port bow after Test B.

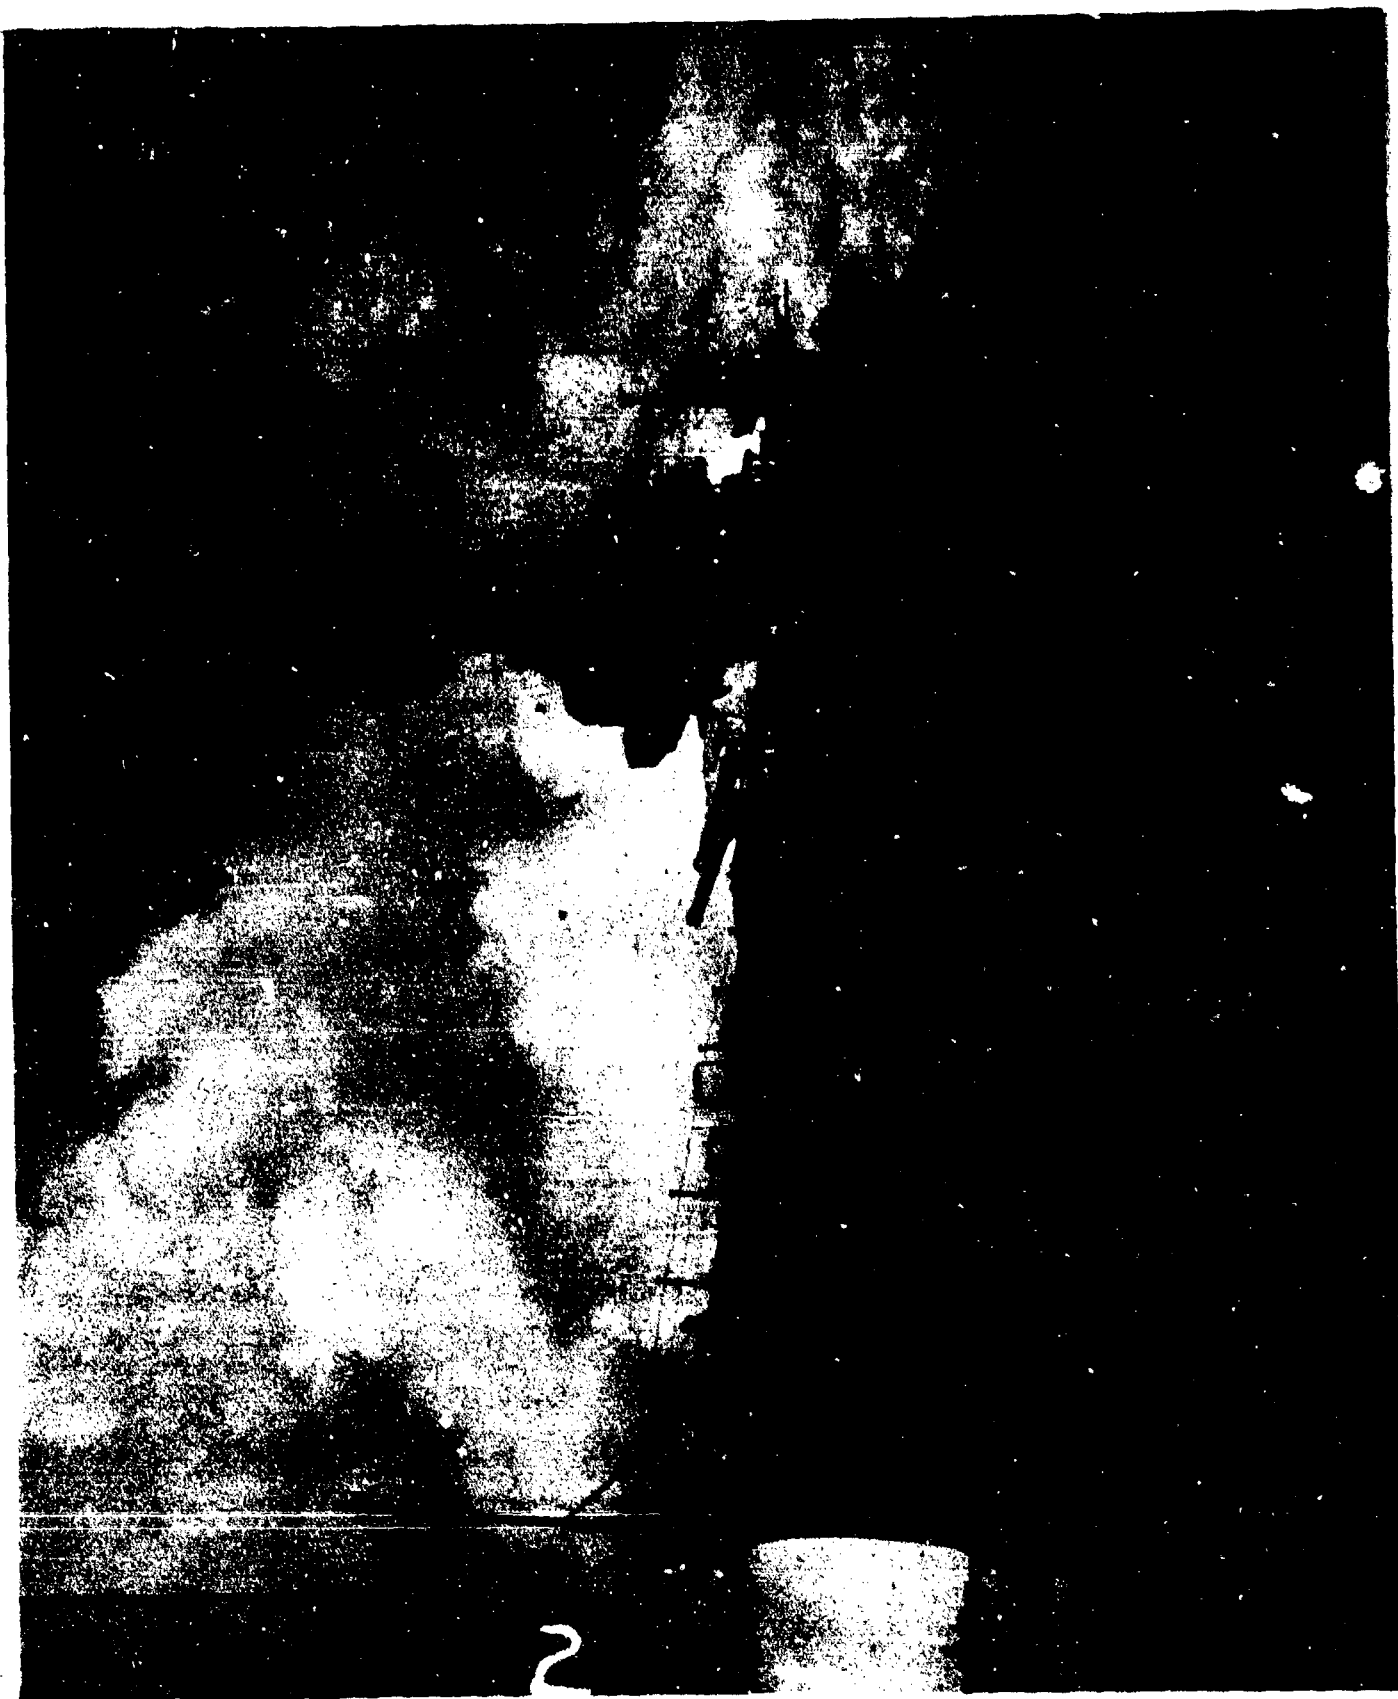
AB-CR-68-2152-2. View of port shell plating and superstructure from port bow.

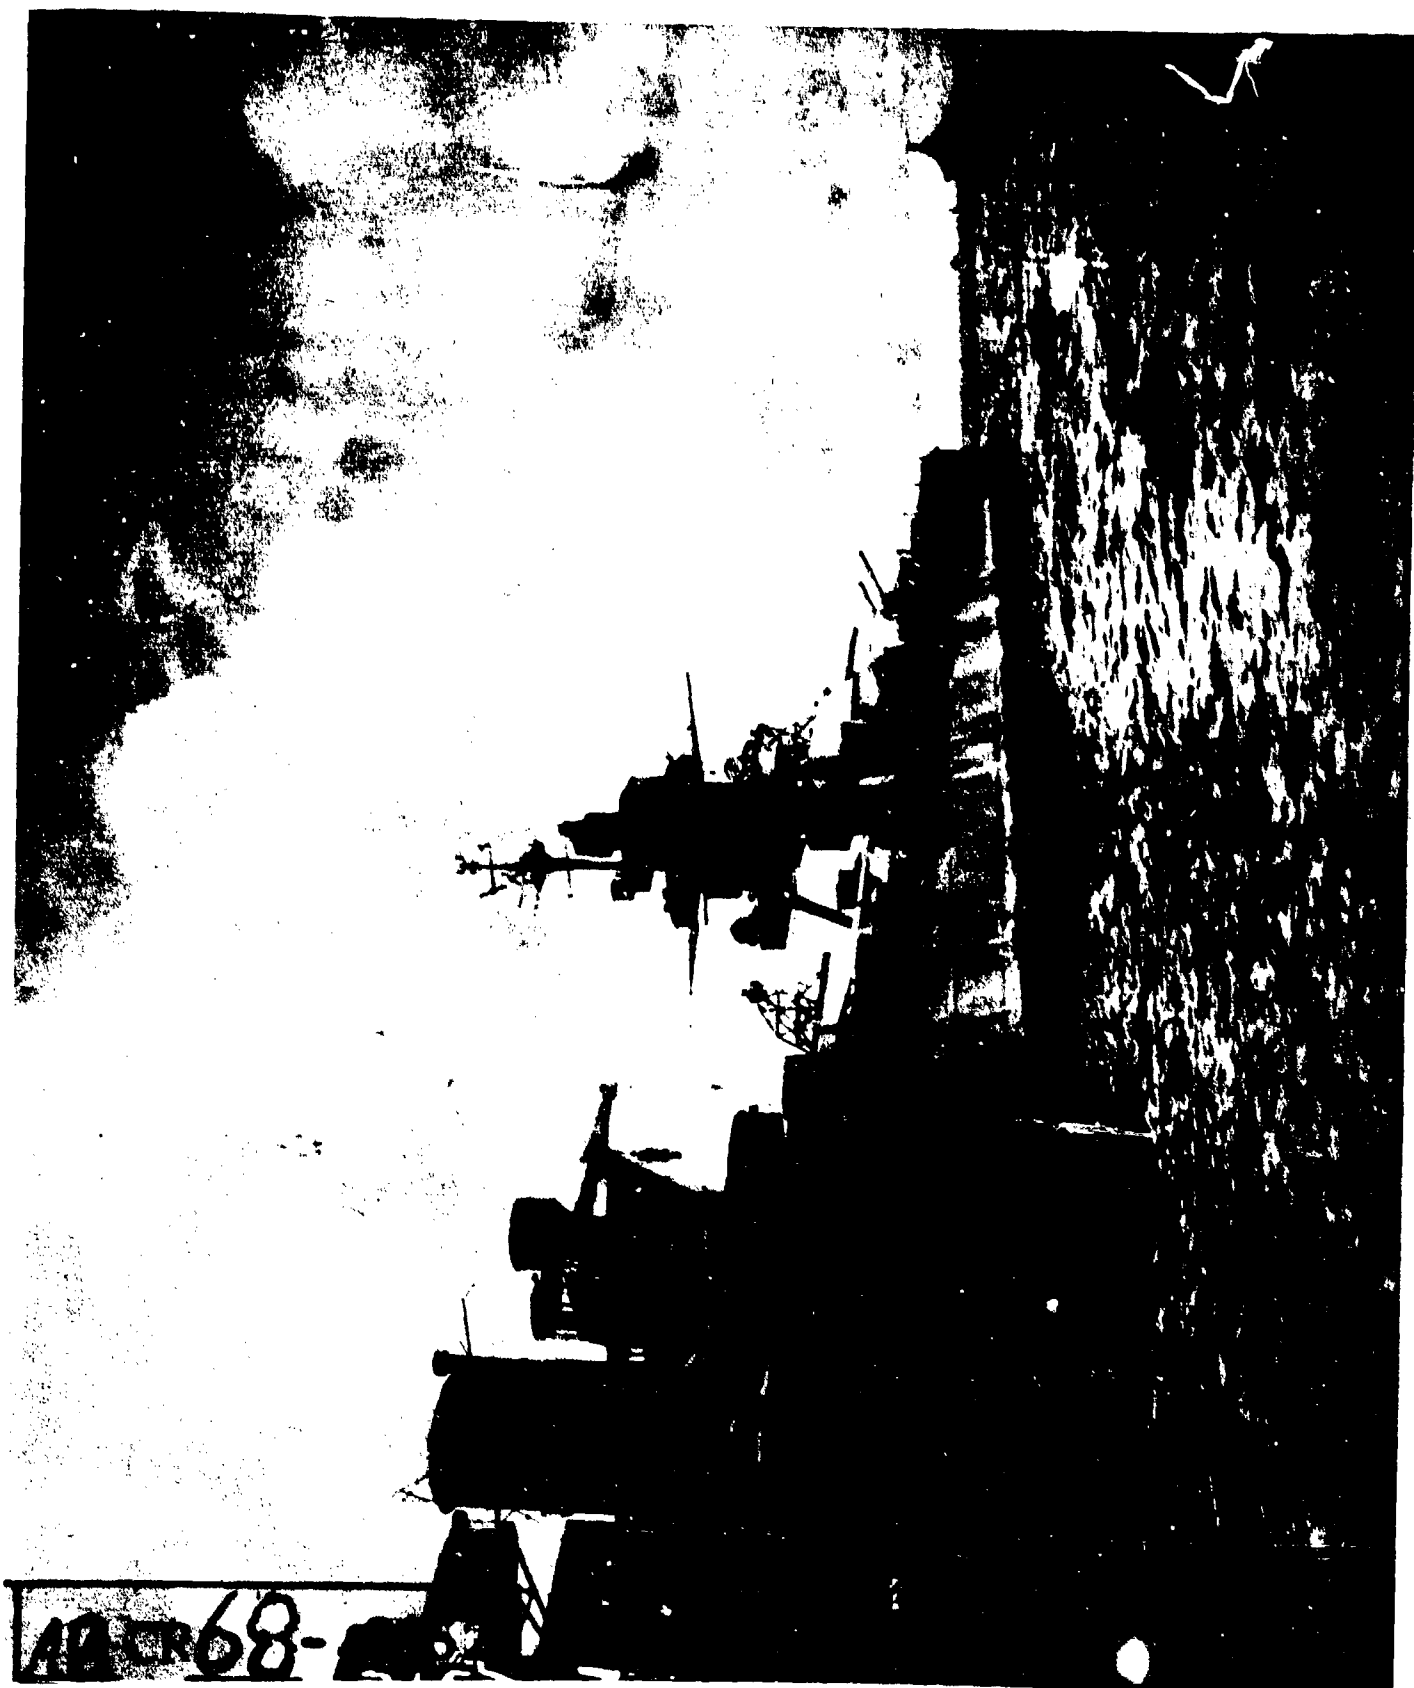
AB-CR-68-2152-3. Port shell plating and after superstructure, looking aft on port side.

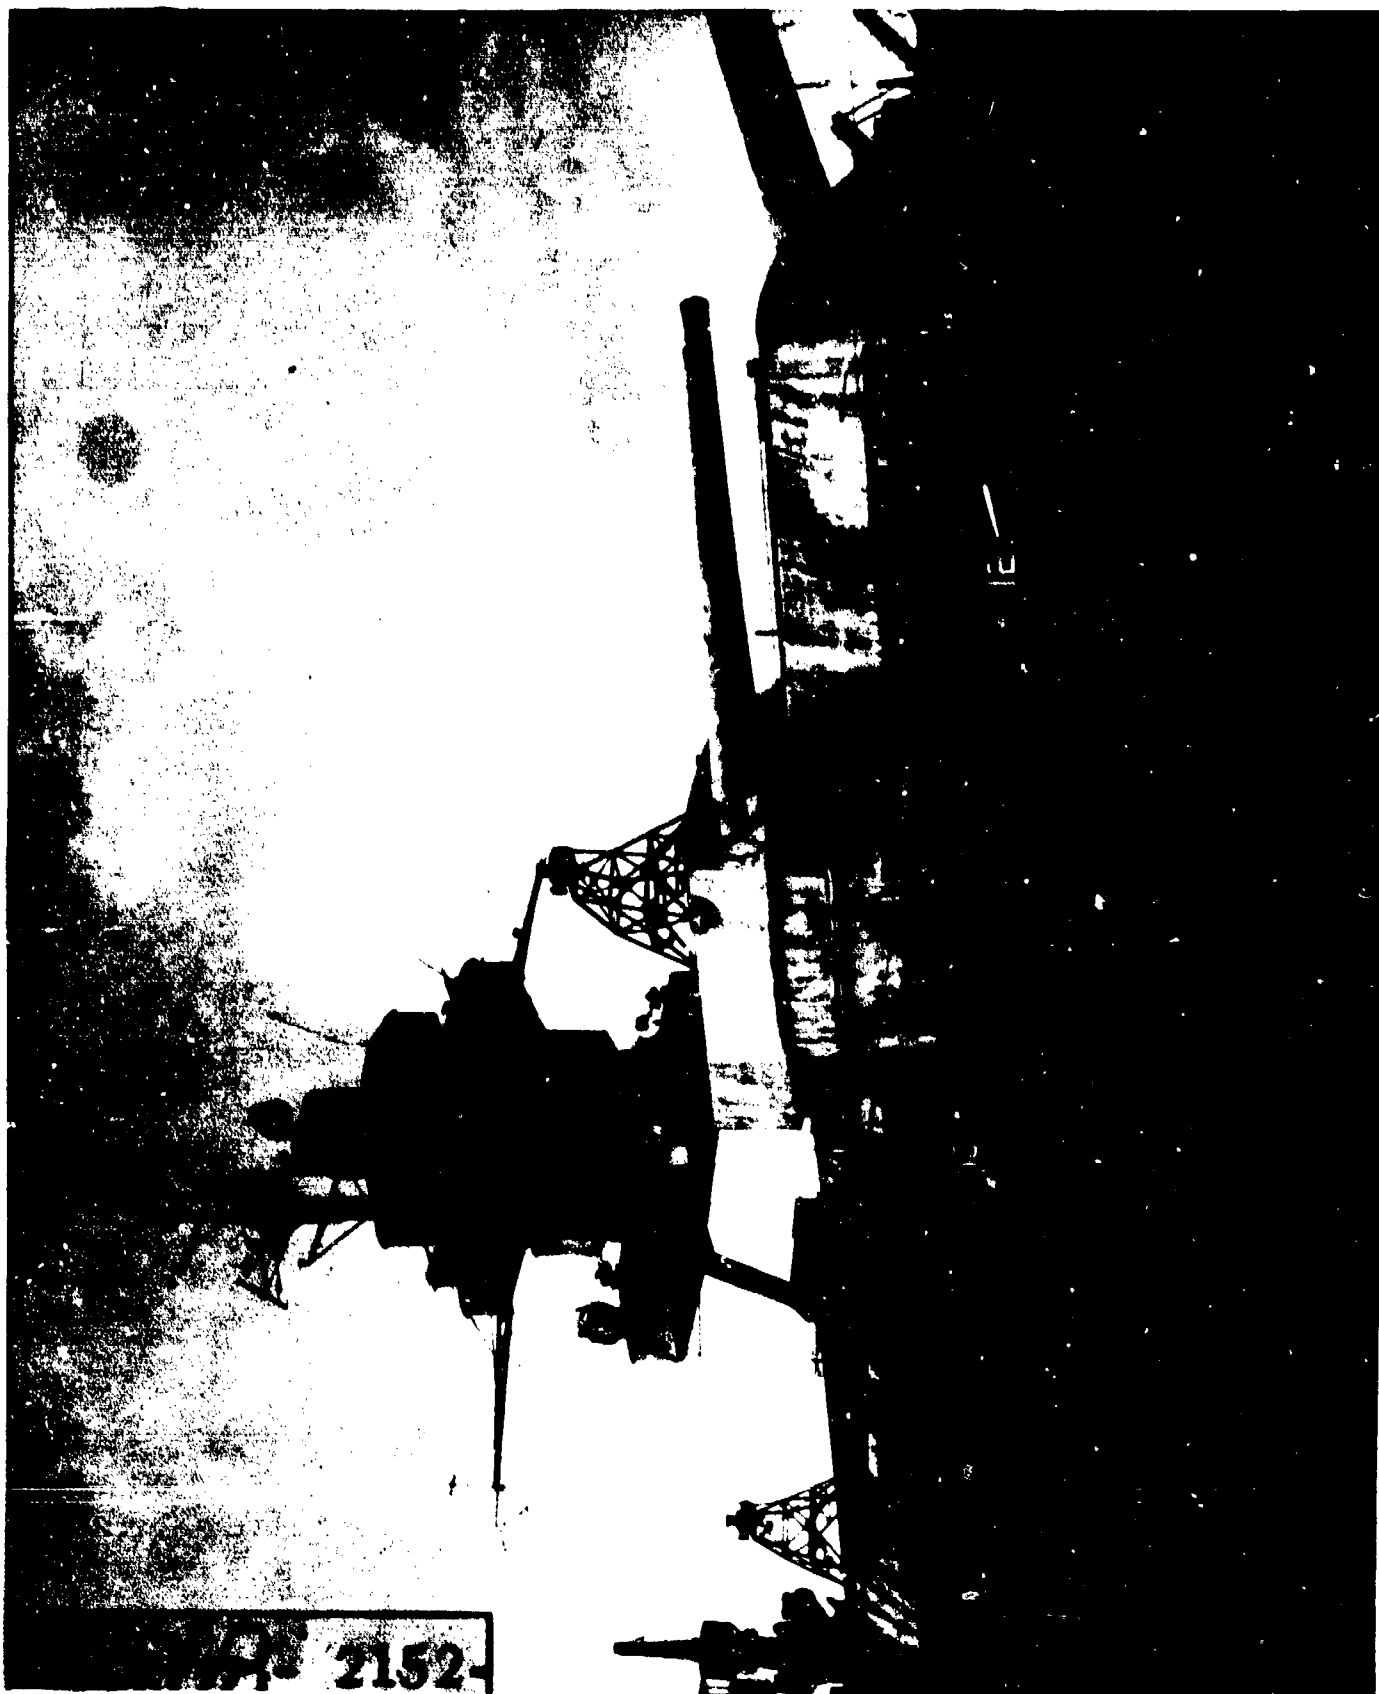
AB-CR-68-2152-6. Port shell plating and after superstructure.

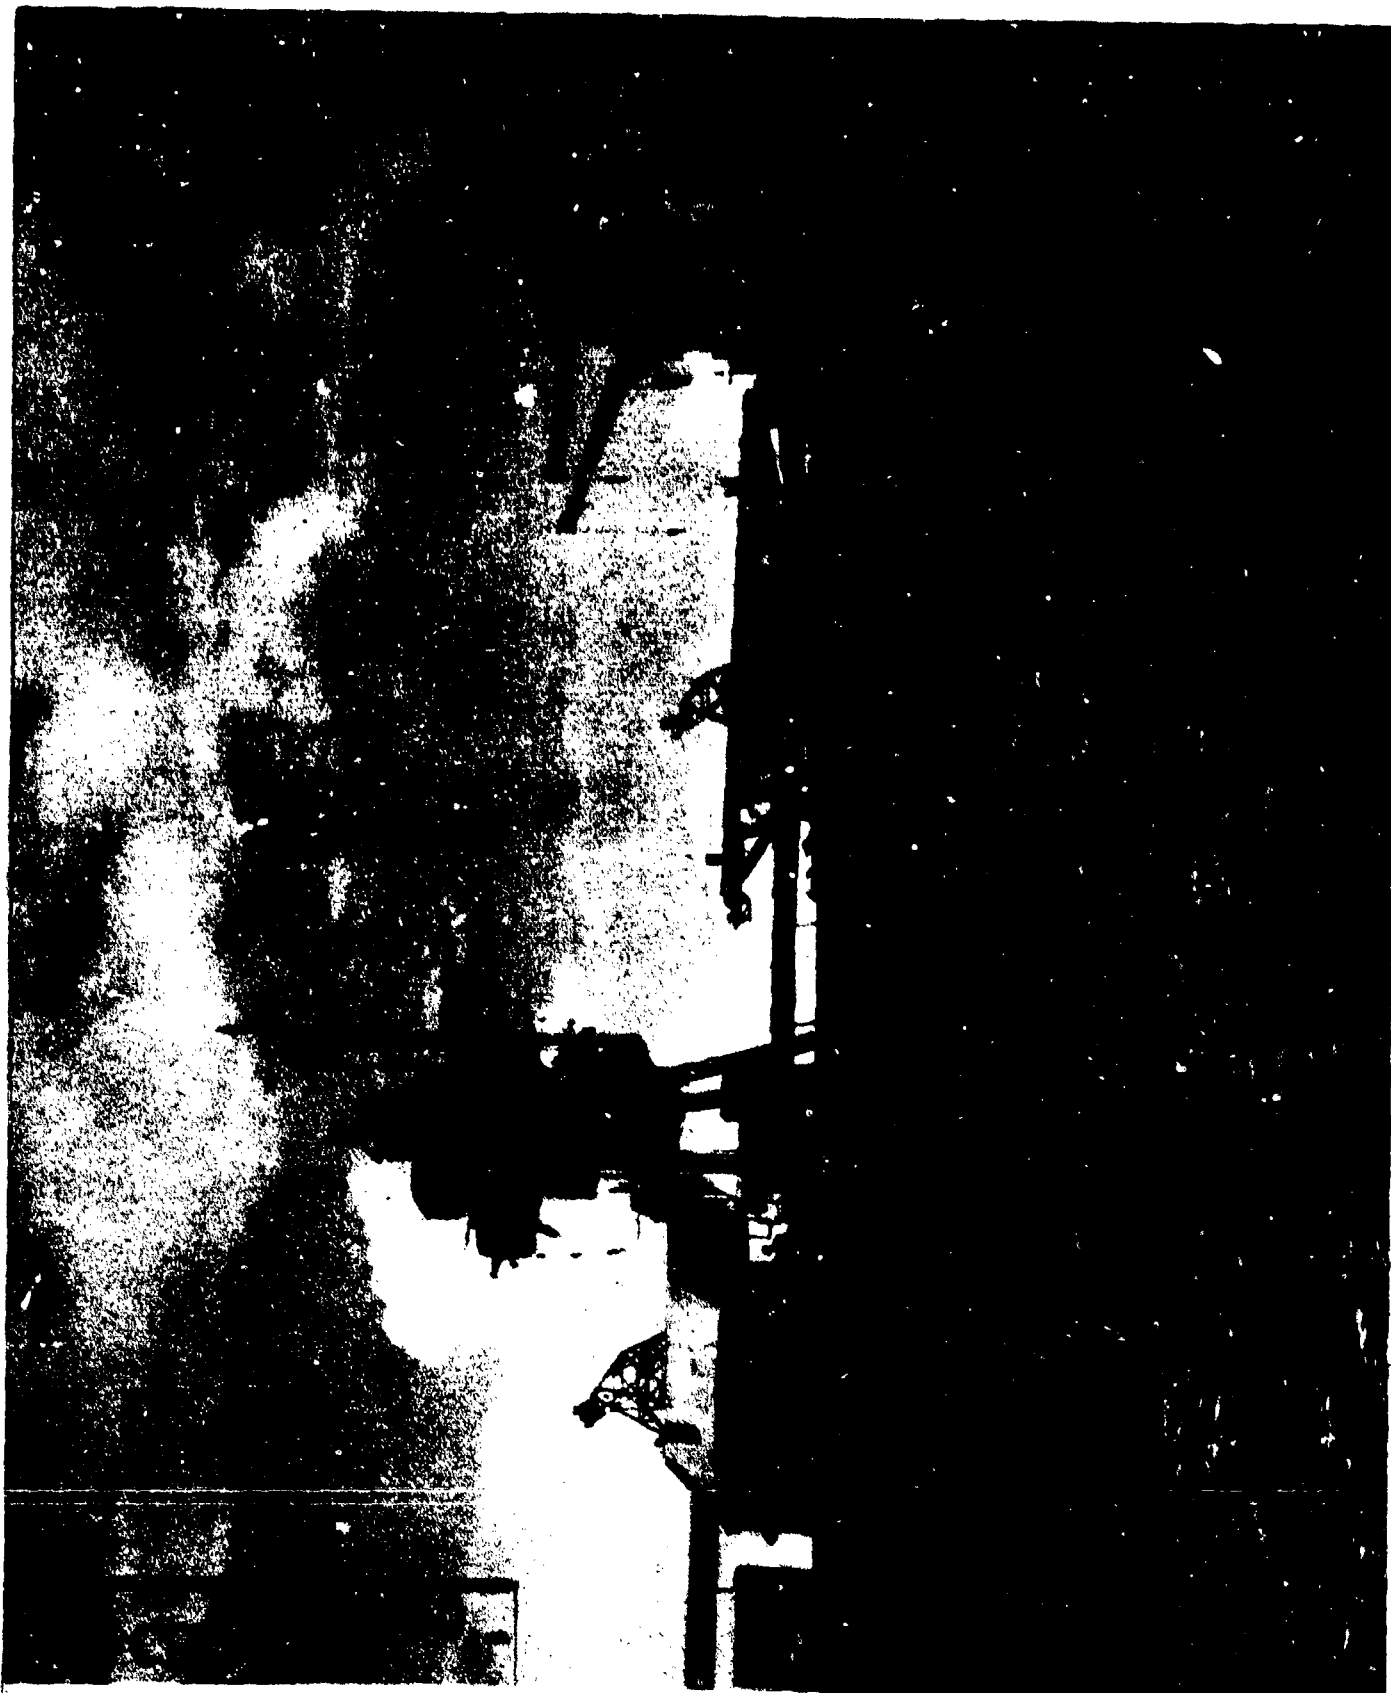
AB-CR-68-2150-11. Starboard shell plating, frames 65 and 115 and superstructure.

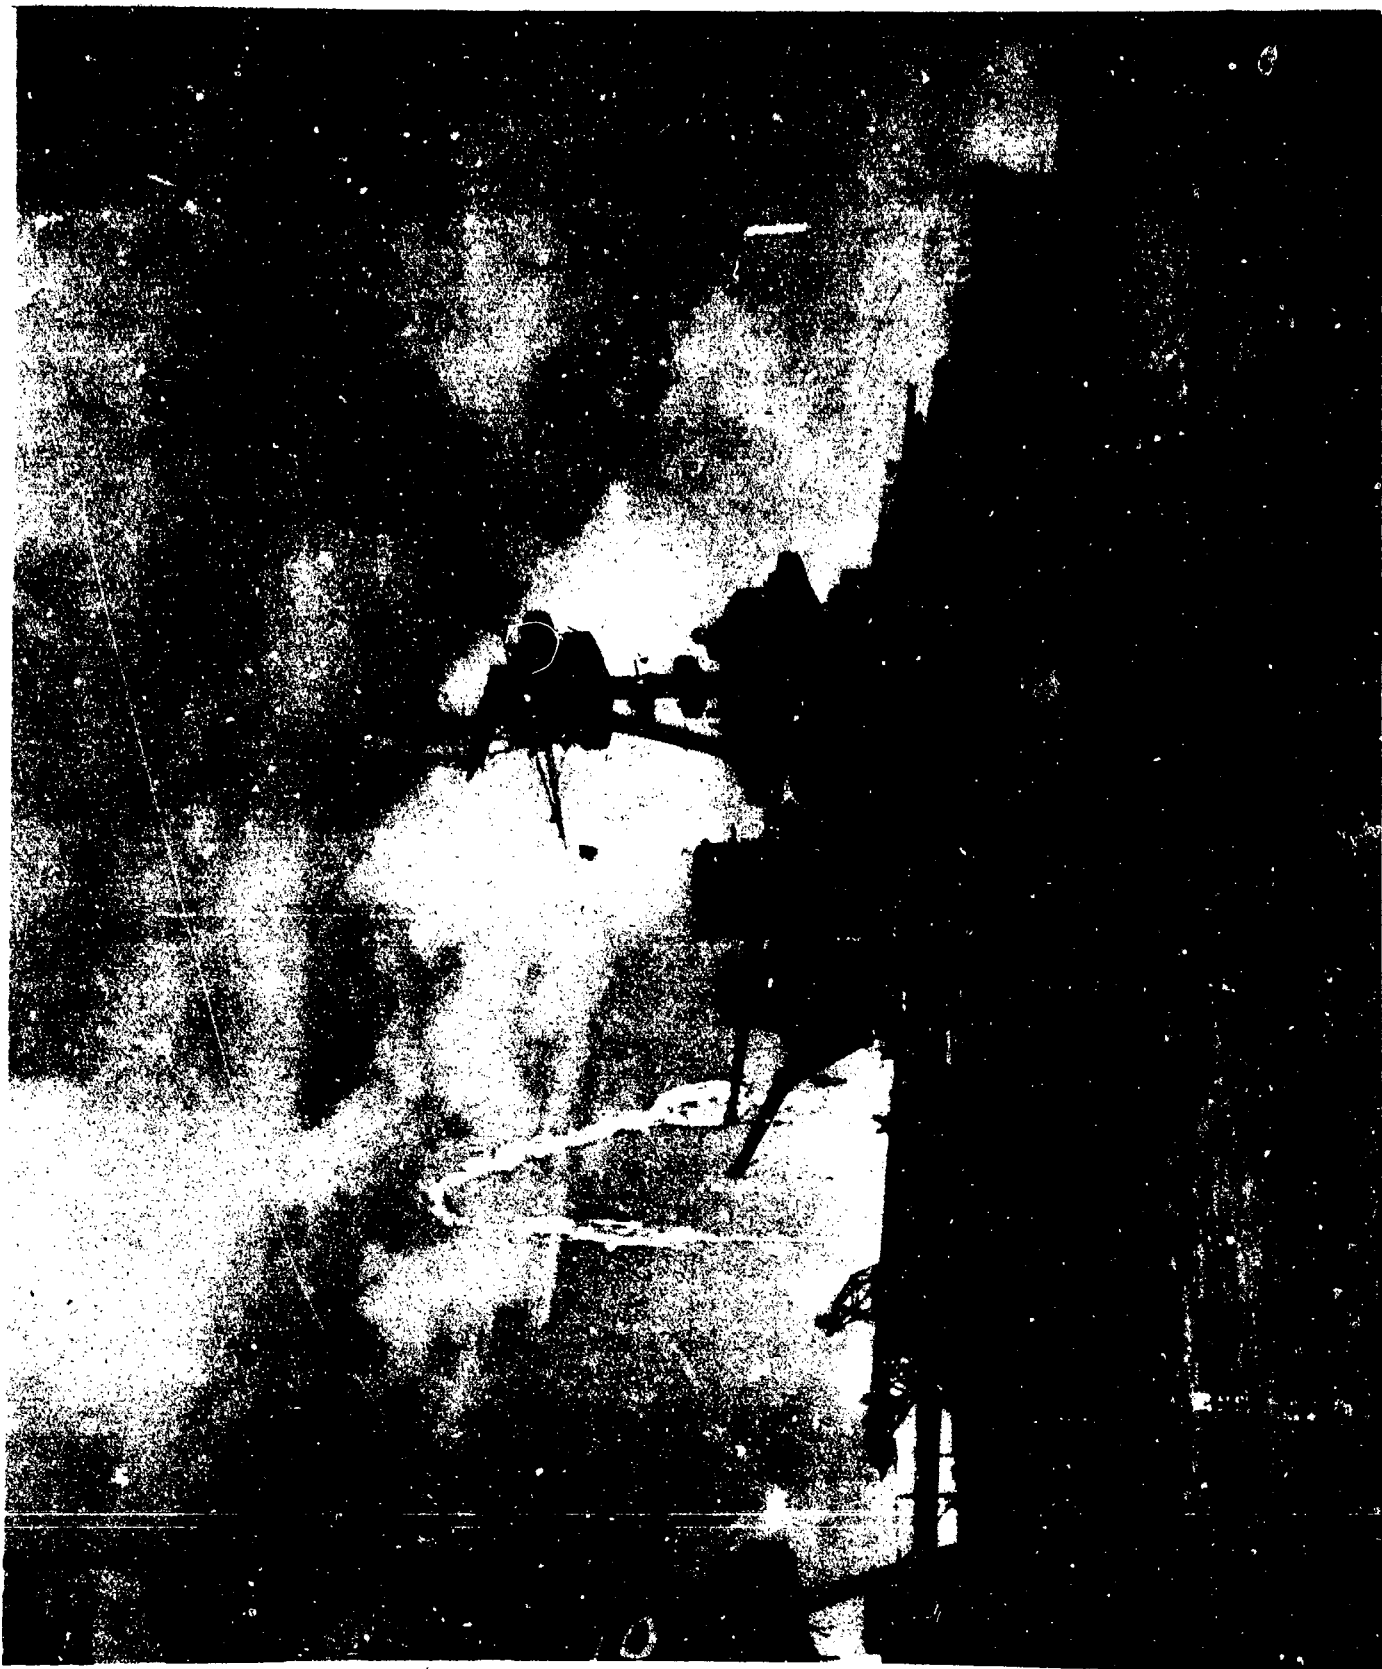
AB-CR-68-2150-10. Starboard shell plating and superstructure, looking forward.

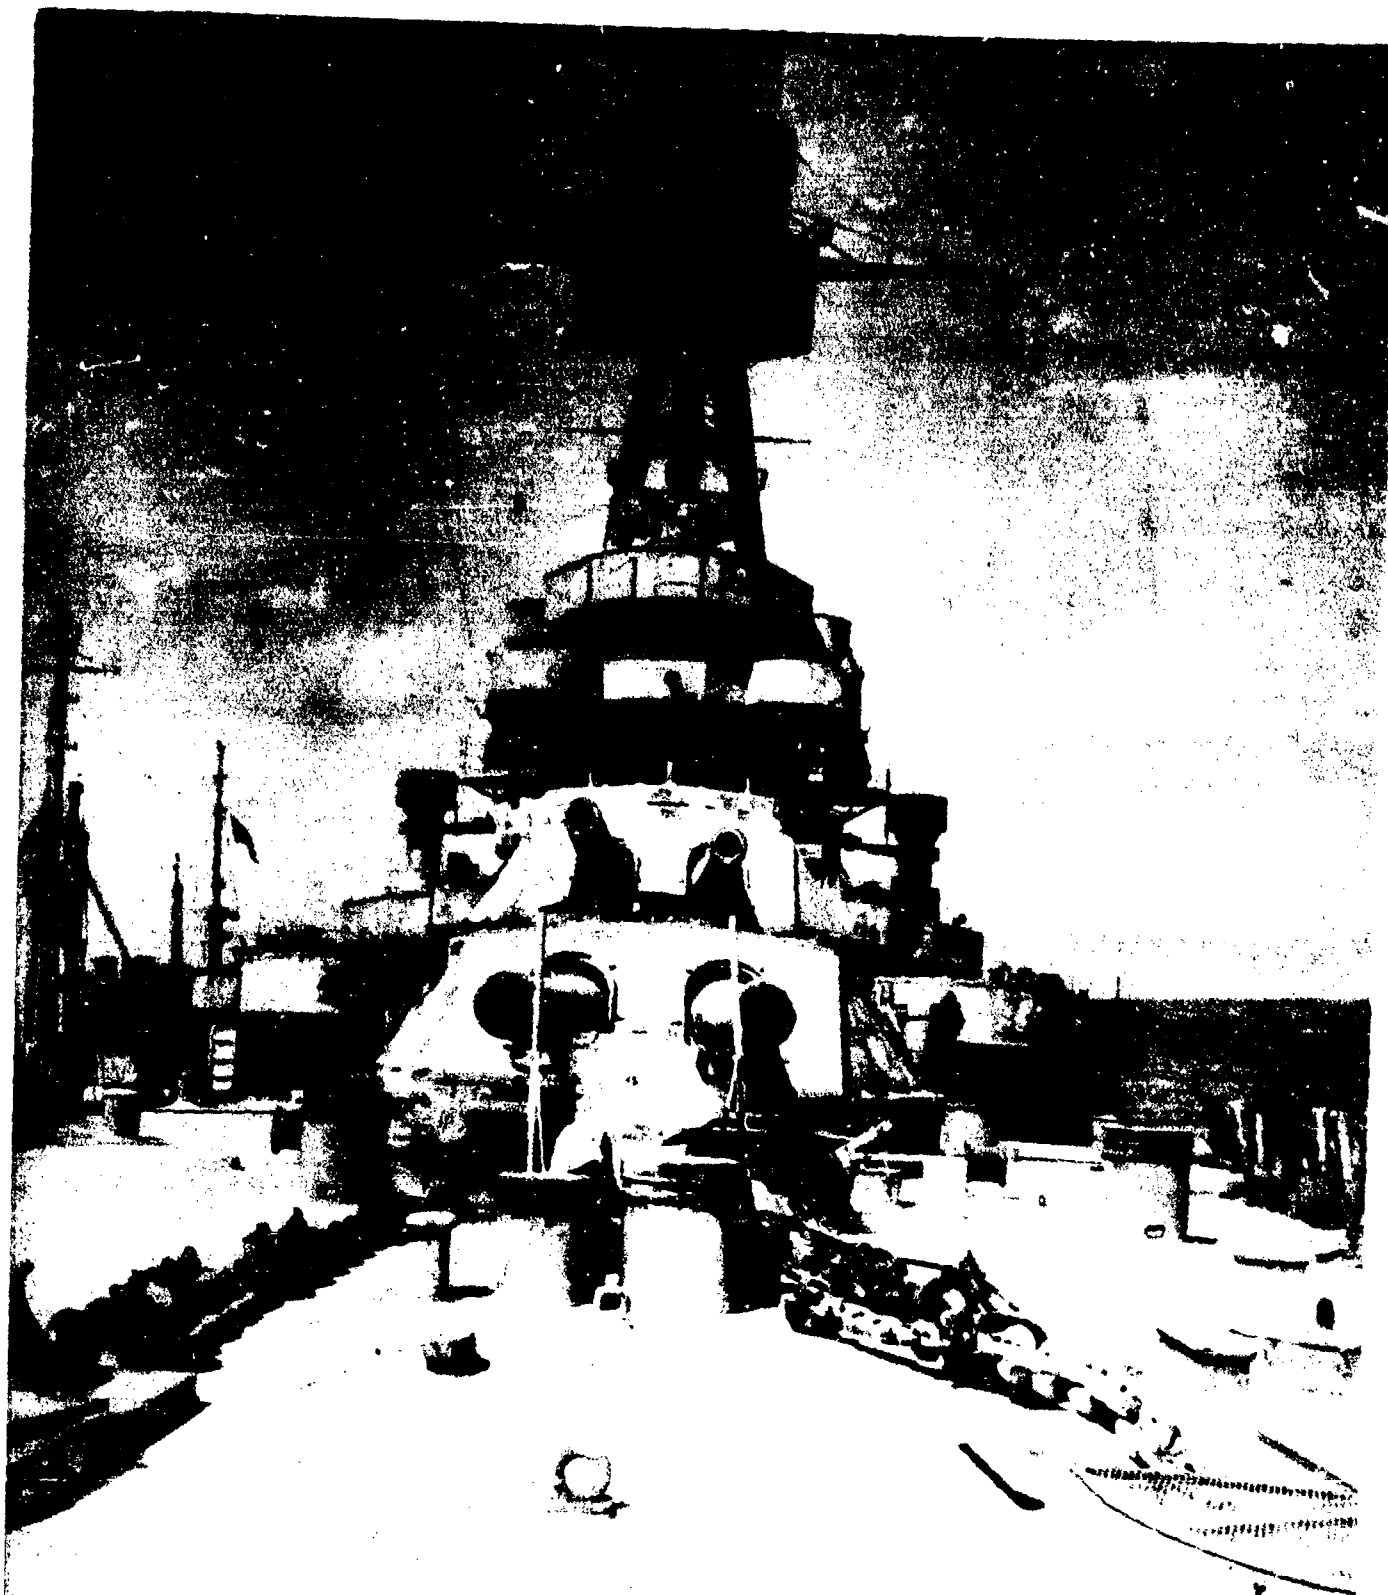
ABCR 68-2953 -1

AB-CR-68-2953-2. Weather deck and forward superstructure from bow of vessel.

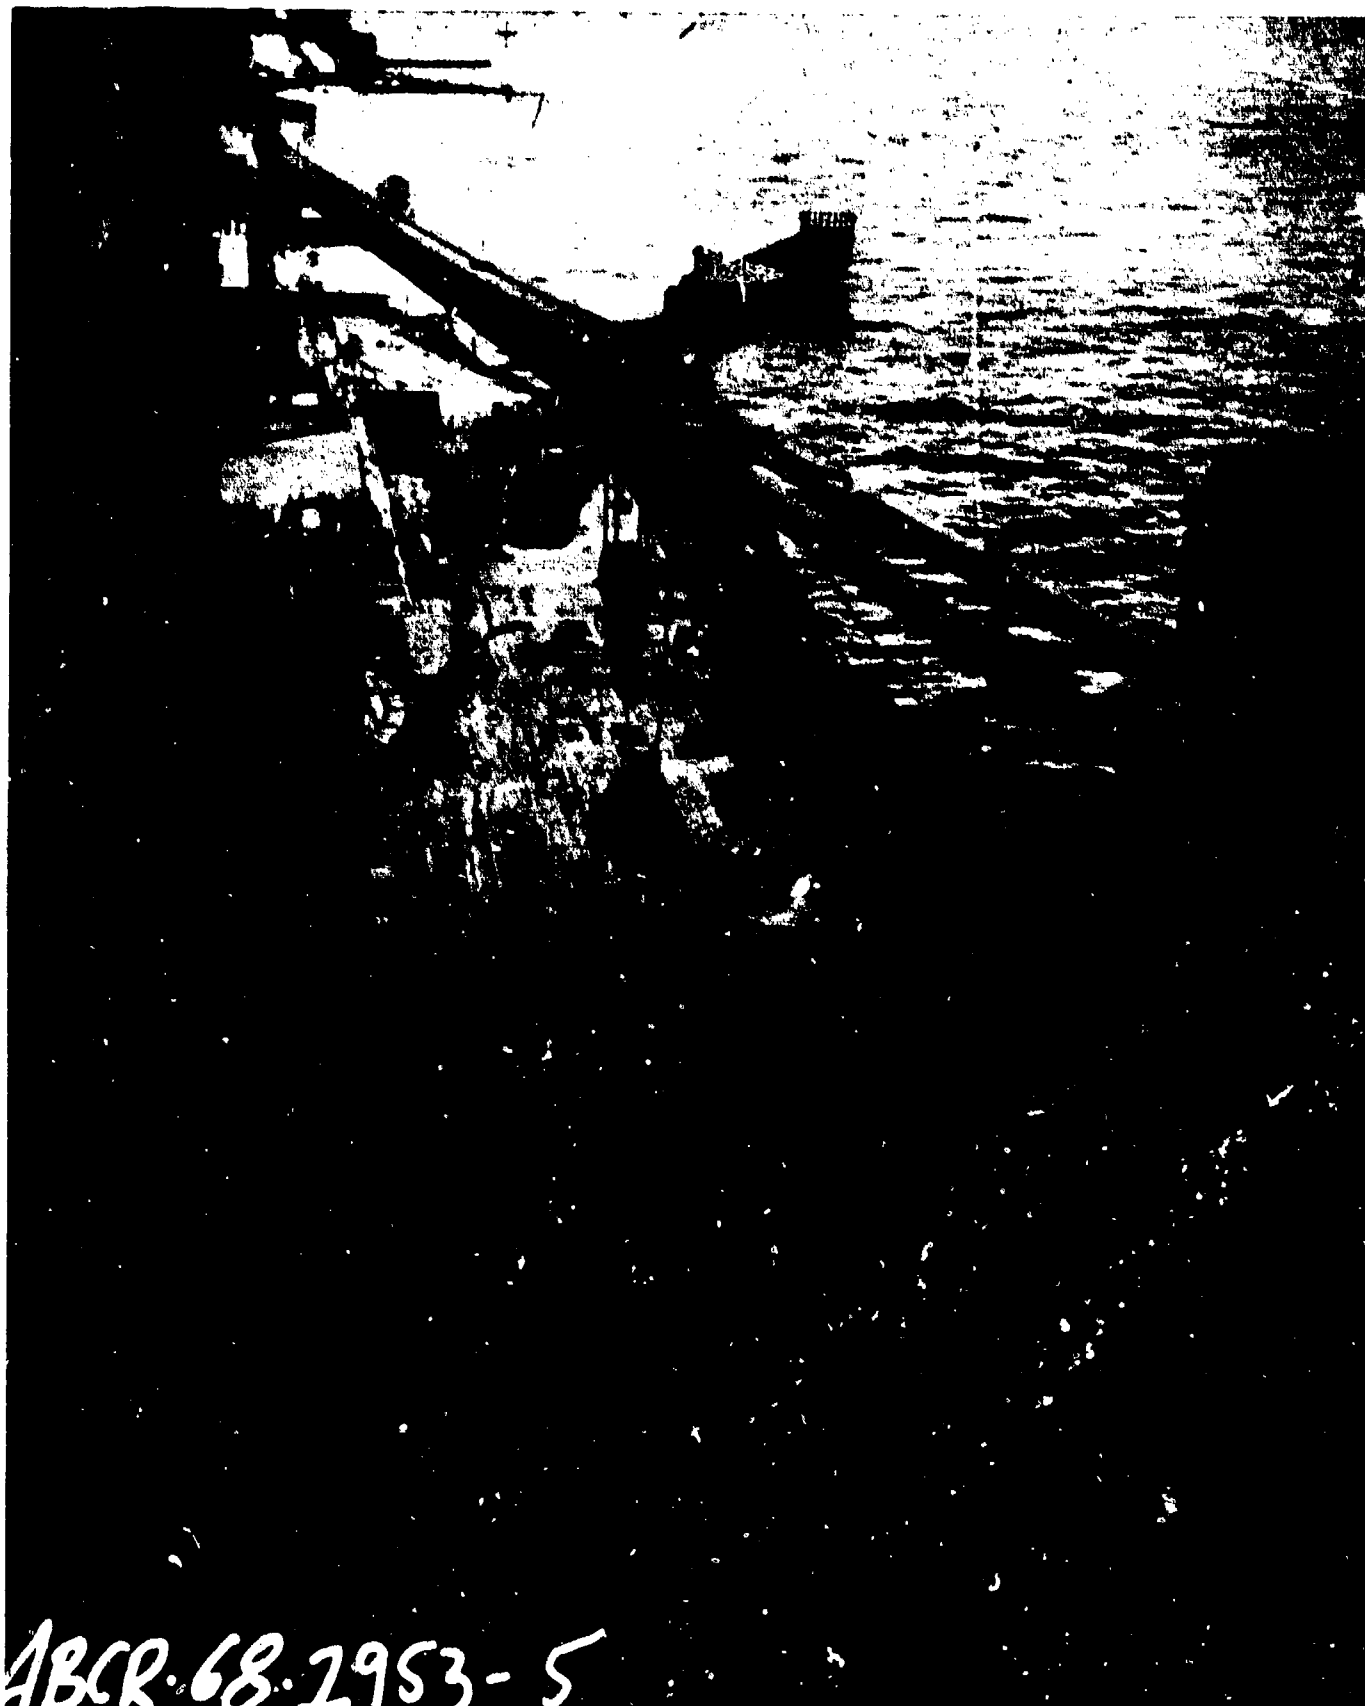
AB-CR-68-2953-5. Looking aft along port side from foremast structure.
